Technical Service Bulletin 195

Mandatory Steering Shaft Connection Inspection and Potential Replacement

Prepared By: B King
Date: December 14, 2021

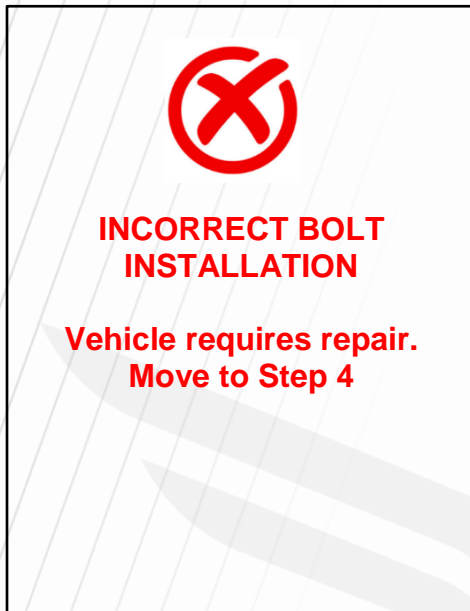
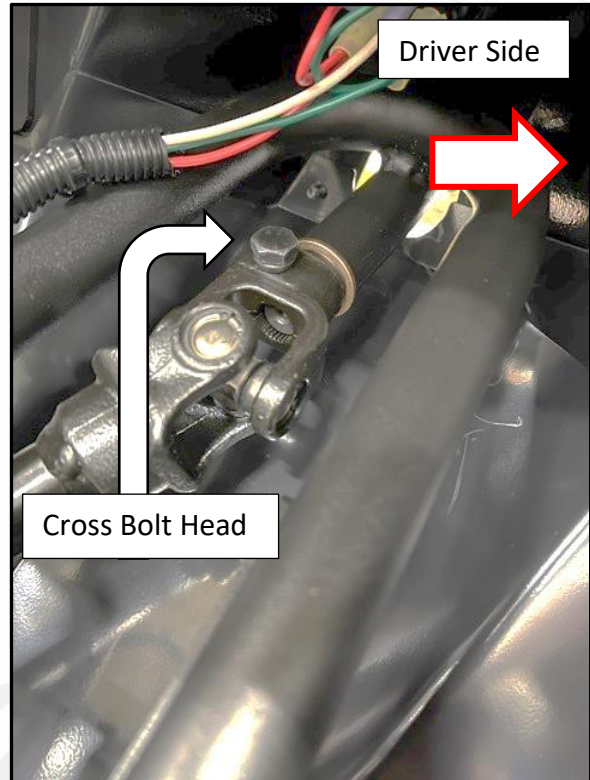
Figure 5 – Incorrect Bolt Installation

Due to a component manufacturing error and/or assembly error, some steering shafts may pull free from the splined steering shaft at the universal joint connection closest to the steering wheel resulting in the potential inability to steer the vehicle.

- Is cross bolt installed correctly (Ref. Figs. 5-6)?

**INCORRECT INSTALLATION****Vehicle requires repair.
Move to Step 4**

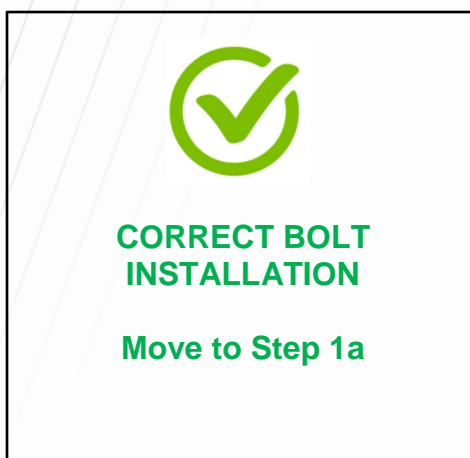
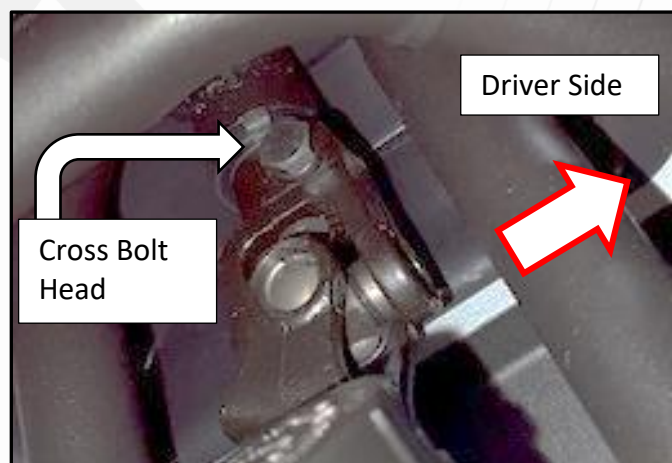
Figure 6 – Correct Cross Bolt Installation

Rotate steering such that U-Joint is oriented as shown in Fig. 6 with Cross Bolt Head Facing UP.

A loose cross bolt will result in excess play between the U-Joint and Spline Shaft. If the unit has passed all the above inspections, ensure the cross bolt (Ref. Figs 6 and 8) is tightened securely with the 13mm socket and ratchet (If you have a torque wrench, tighten to 20lb/ft). After tightening the cross bolt, move on to Step 3 – Tug Test.

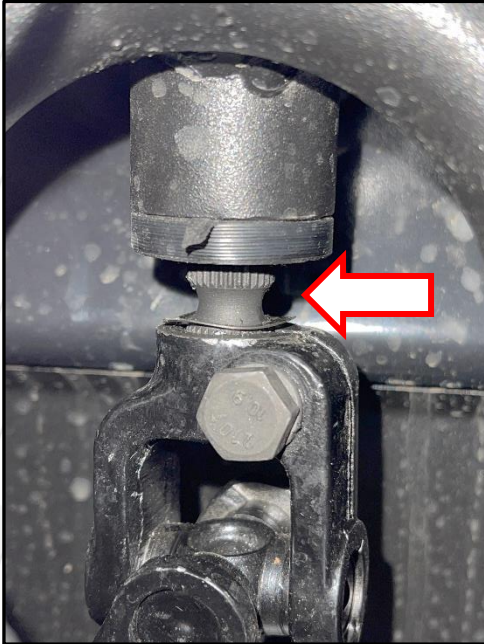
Figure 7 – Incorrect Engagement

Ensure the U-Joint is fully engaged on the splined steering shaft. Incorrect engagement will result in a gap between U-Joint and steering support tube. Ref. Figs. 7-8.
