Technical Service Bulletin 195

Mandatory Steering Shaft Connection Inspection and Potential Replacement

Prepared By: B King
Date: December 14, 2021

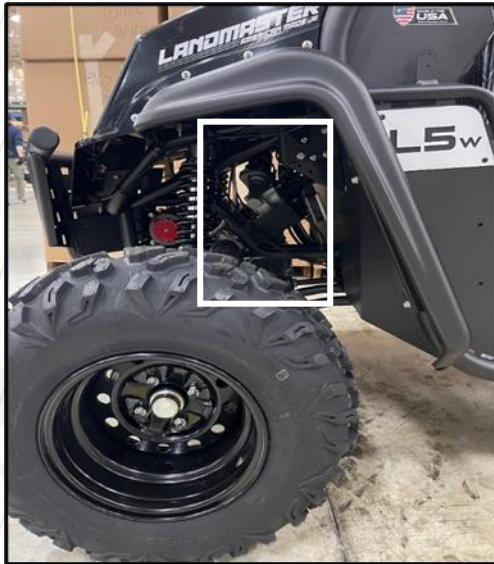
Figure 1 - General Location

- 1- From the driver side of the vehicle, look for a power steering module and electronic control box as shown in Figs 1-2.
- 2- If Power Steering Module is present, the vehicle IS equipped with Electronic Power Steering and **no further action is required.** If the power steering module and electronic control box are NOT present on your vehicle, please continue to Section B - Determine if Your Manual Steering Vehicle is affected.

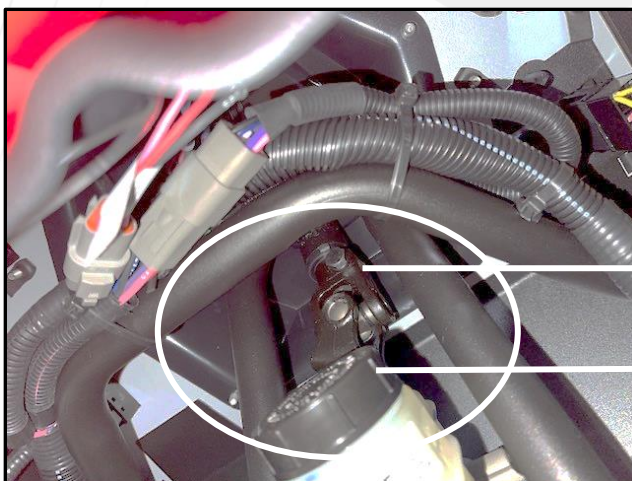
Figure 4 – Upper U Joint location

Upper U-Joint connection is located just above the master cylinder as shown below in Fig. 4.
